Attached please find the Final Report for the Inver Grove Heights Northwest Area Natural Resource Inventory and Management Plan.

City of
Inver Grove Heights
Northwest Expansion Area

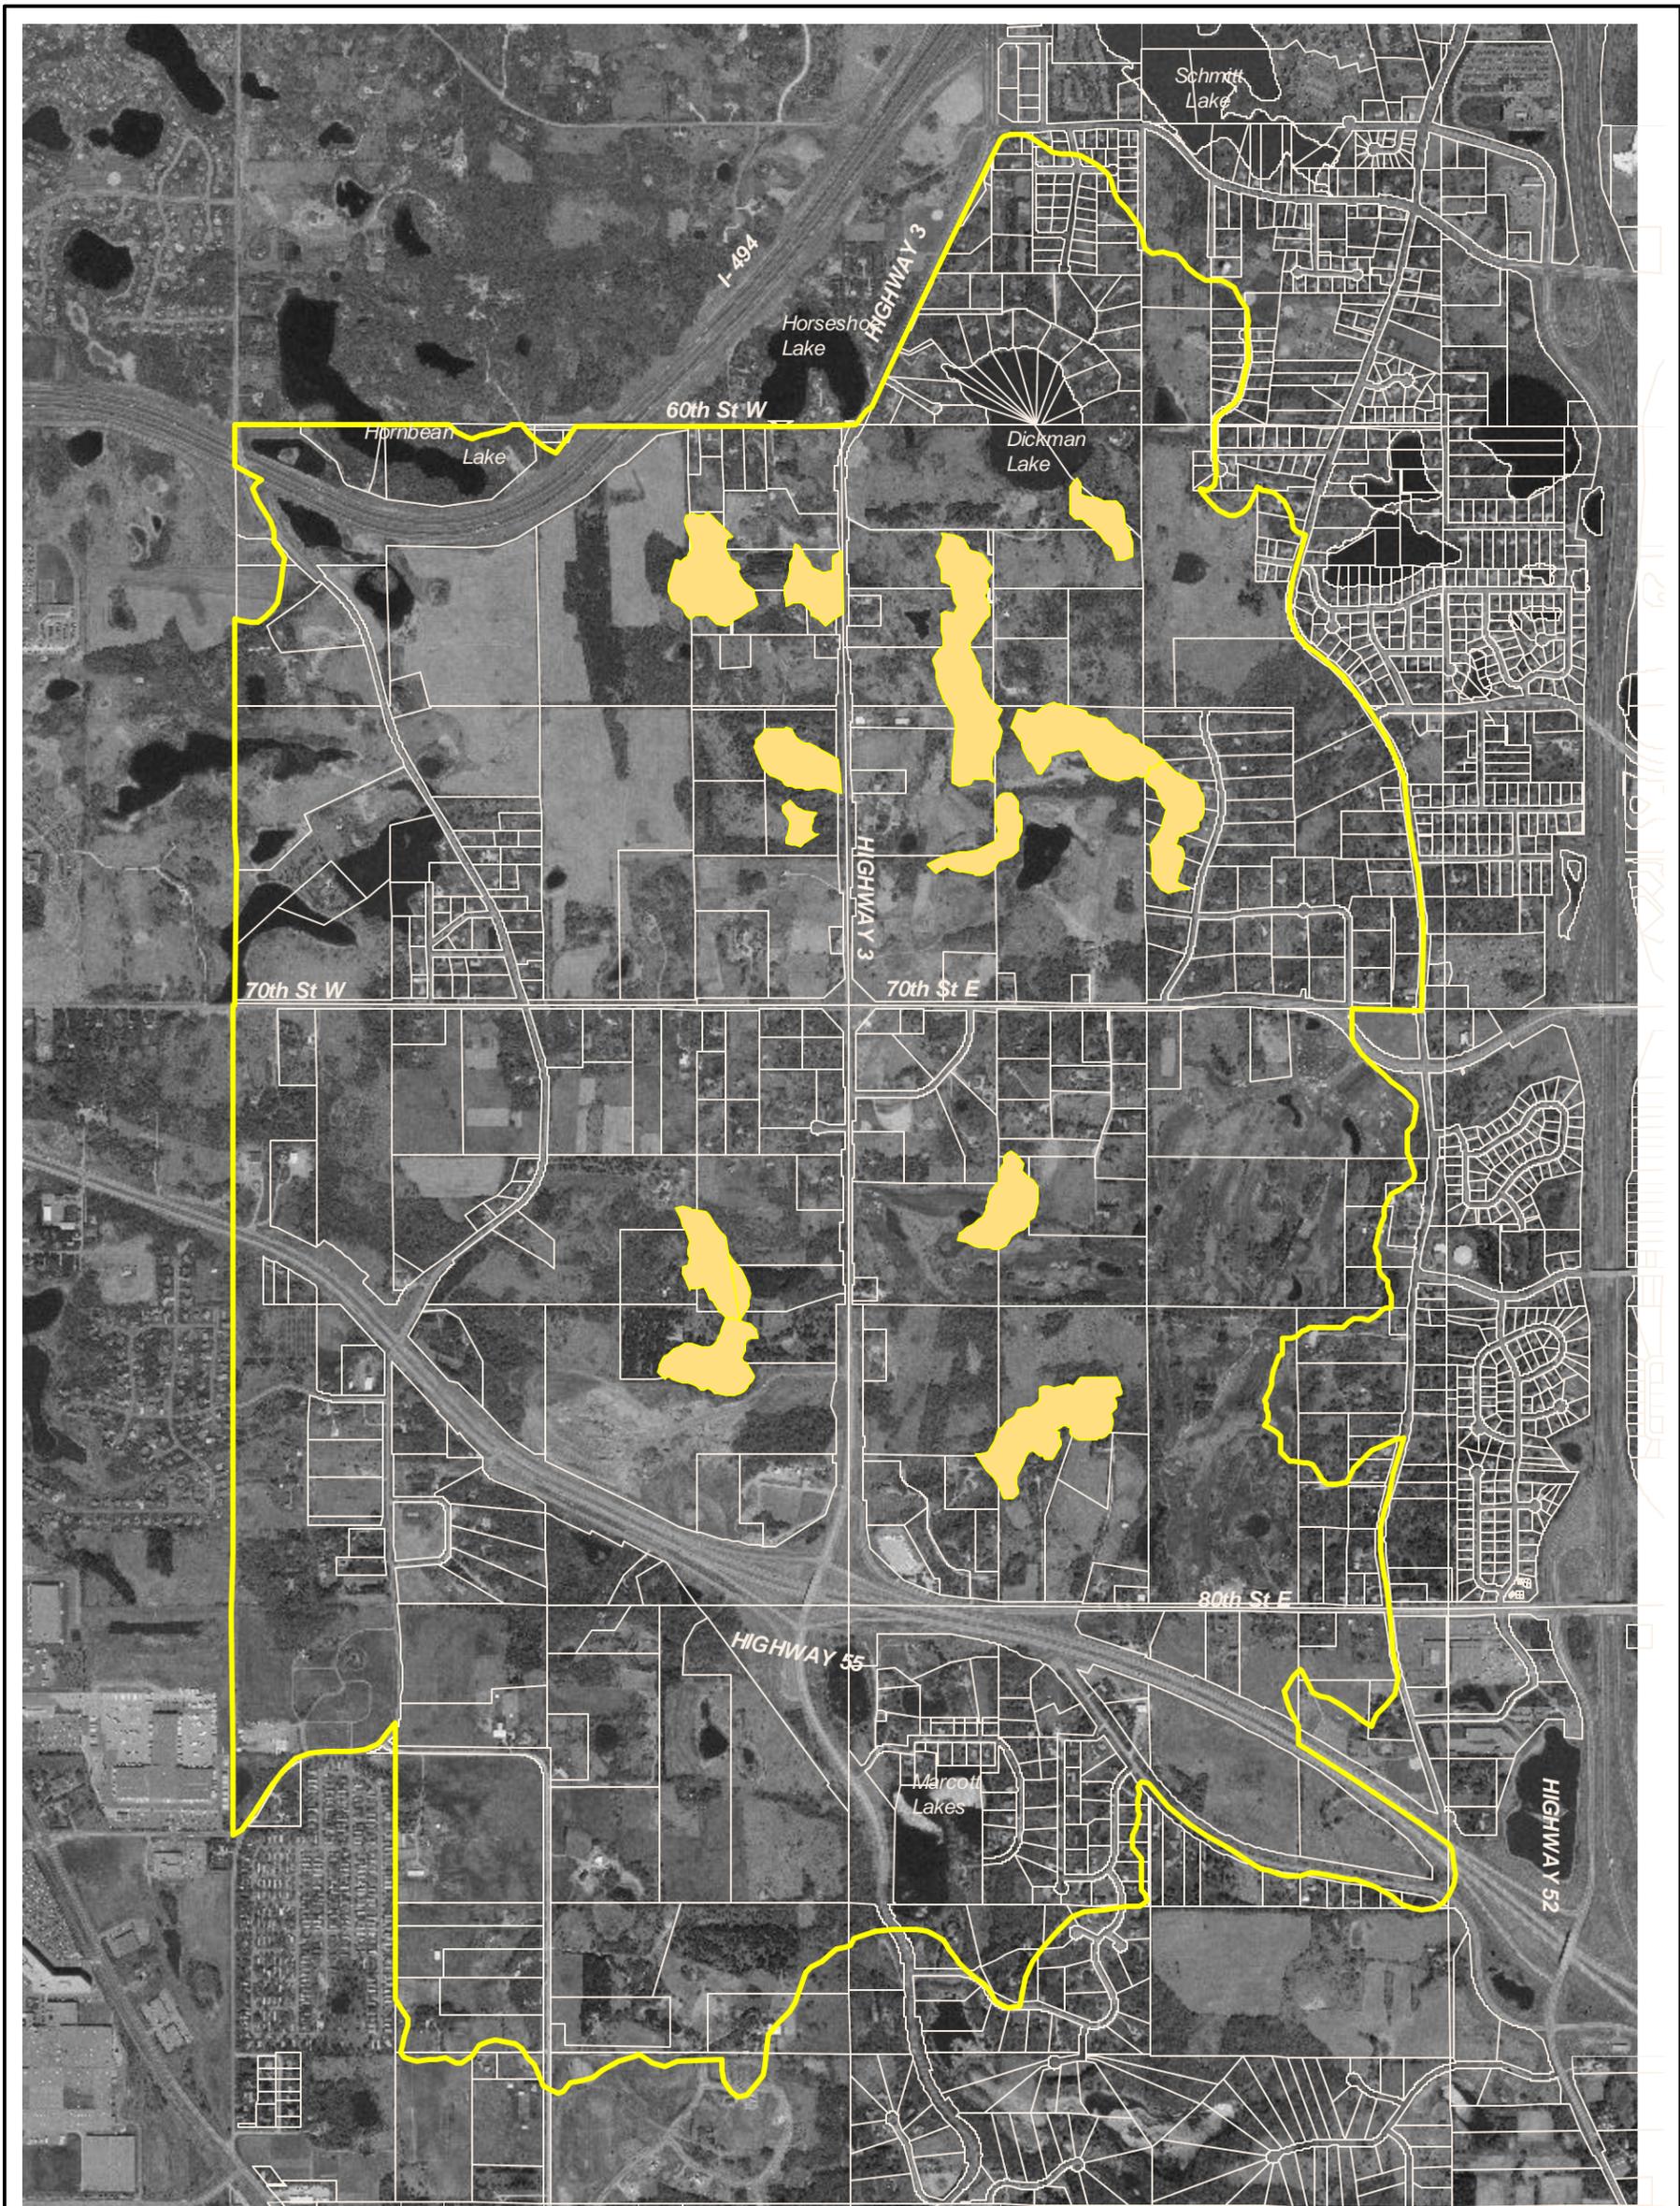
Steep Slopes

Refer to Steep Slope Analysis Figure

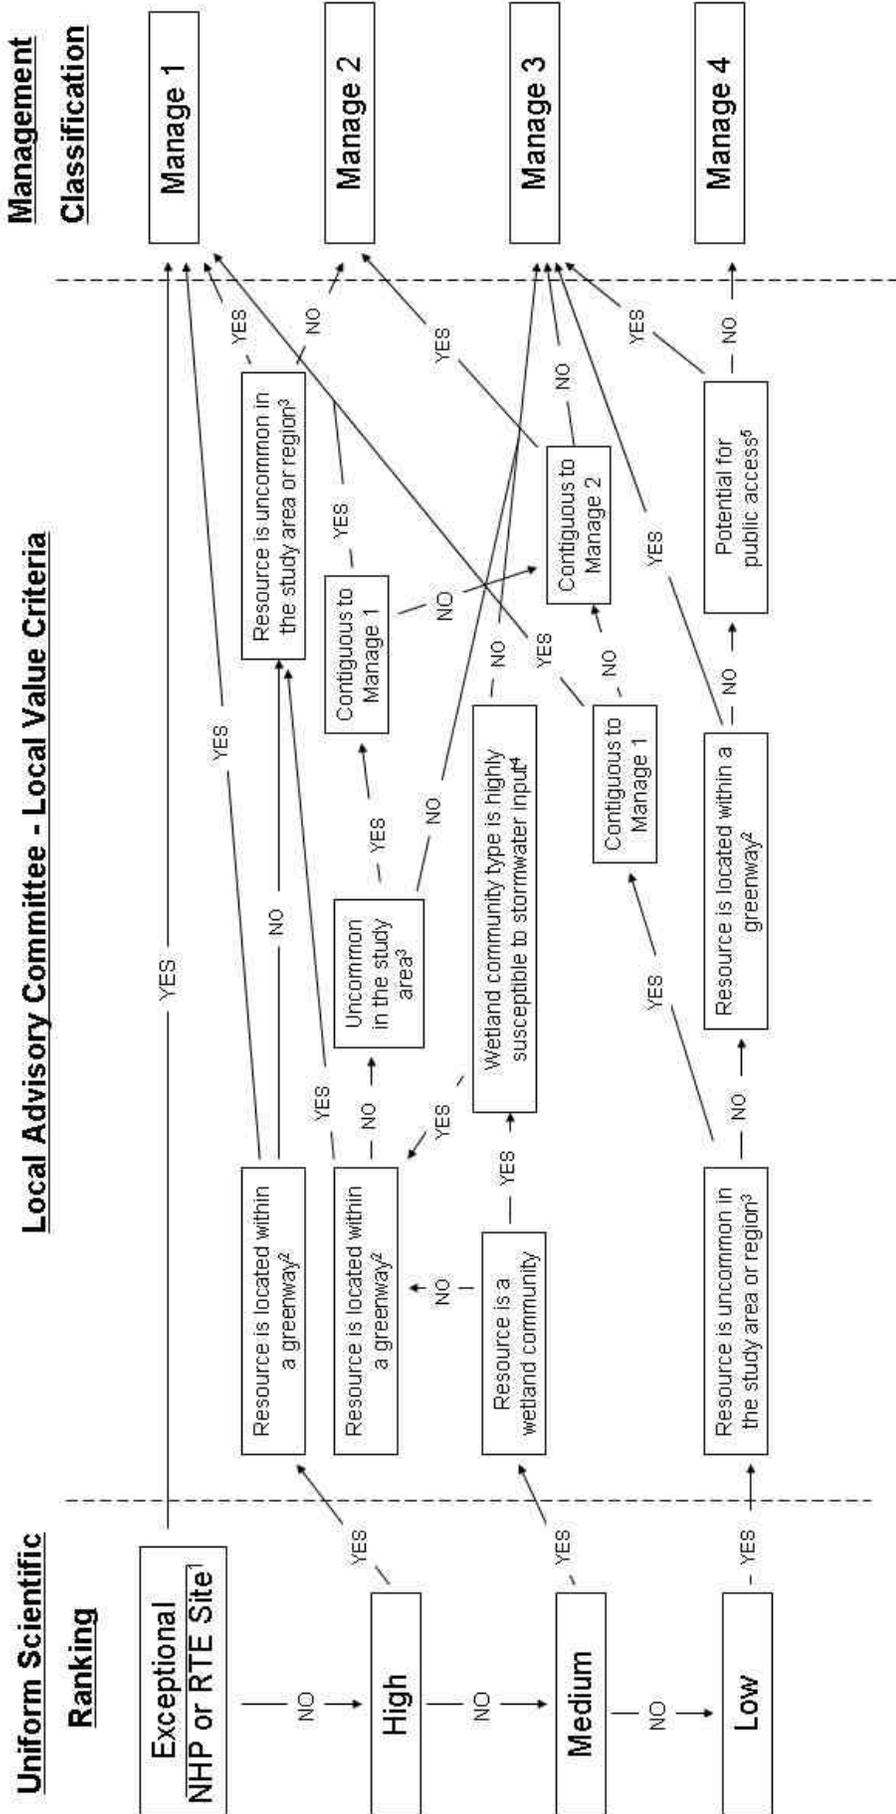
The Local Local Advisory Committee input process was facilitated by and City staff and Bonestroo & Associates who provided technical information regarding natural resource issues and recorded outcomes of the committee meetings. Additional information is given on the flowchart on page 4-10.

¹ Site is part of, or within 200 feet of, a site identified by the MnDNR Natural Heritage Program (NHP) to be a significant natural feature or to be the location of a known occurrence of a rare, threatened, or endangered plant or animal species

² Based on IGH Northwest Expansion Area **preliminary** "greenway", see Northwest Expansion Area NRI Management Classification map

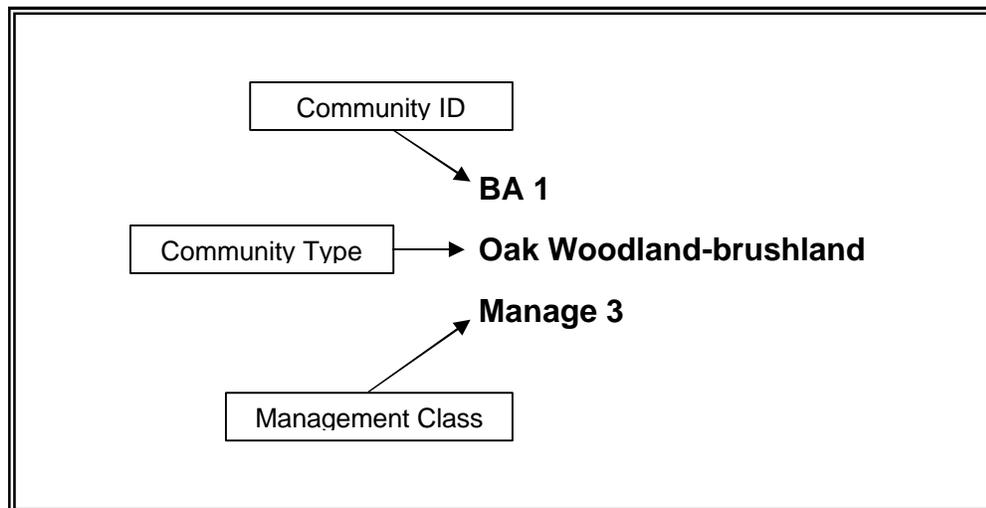
Example community description header:

Each natural community includes a unique alphanumeric code, community type name, management classification, and written description (see example below). Each natural area also has a description of the disturbance indicators noted, restoration potential, and management recommendations. Semi-natural communities are listed at the end of the section for each quadrant. No Management Class is given for these areas.

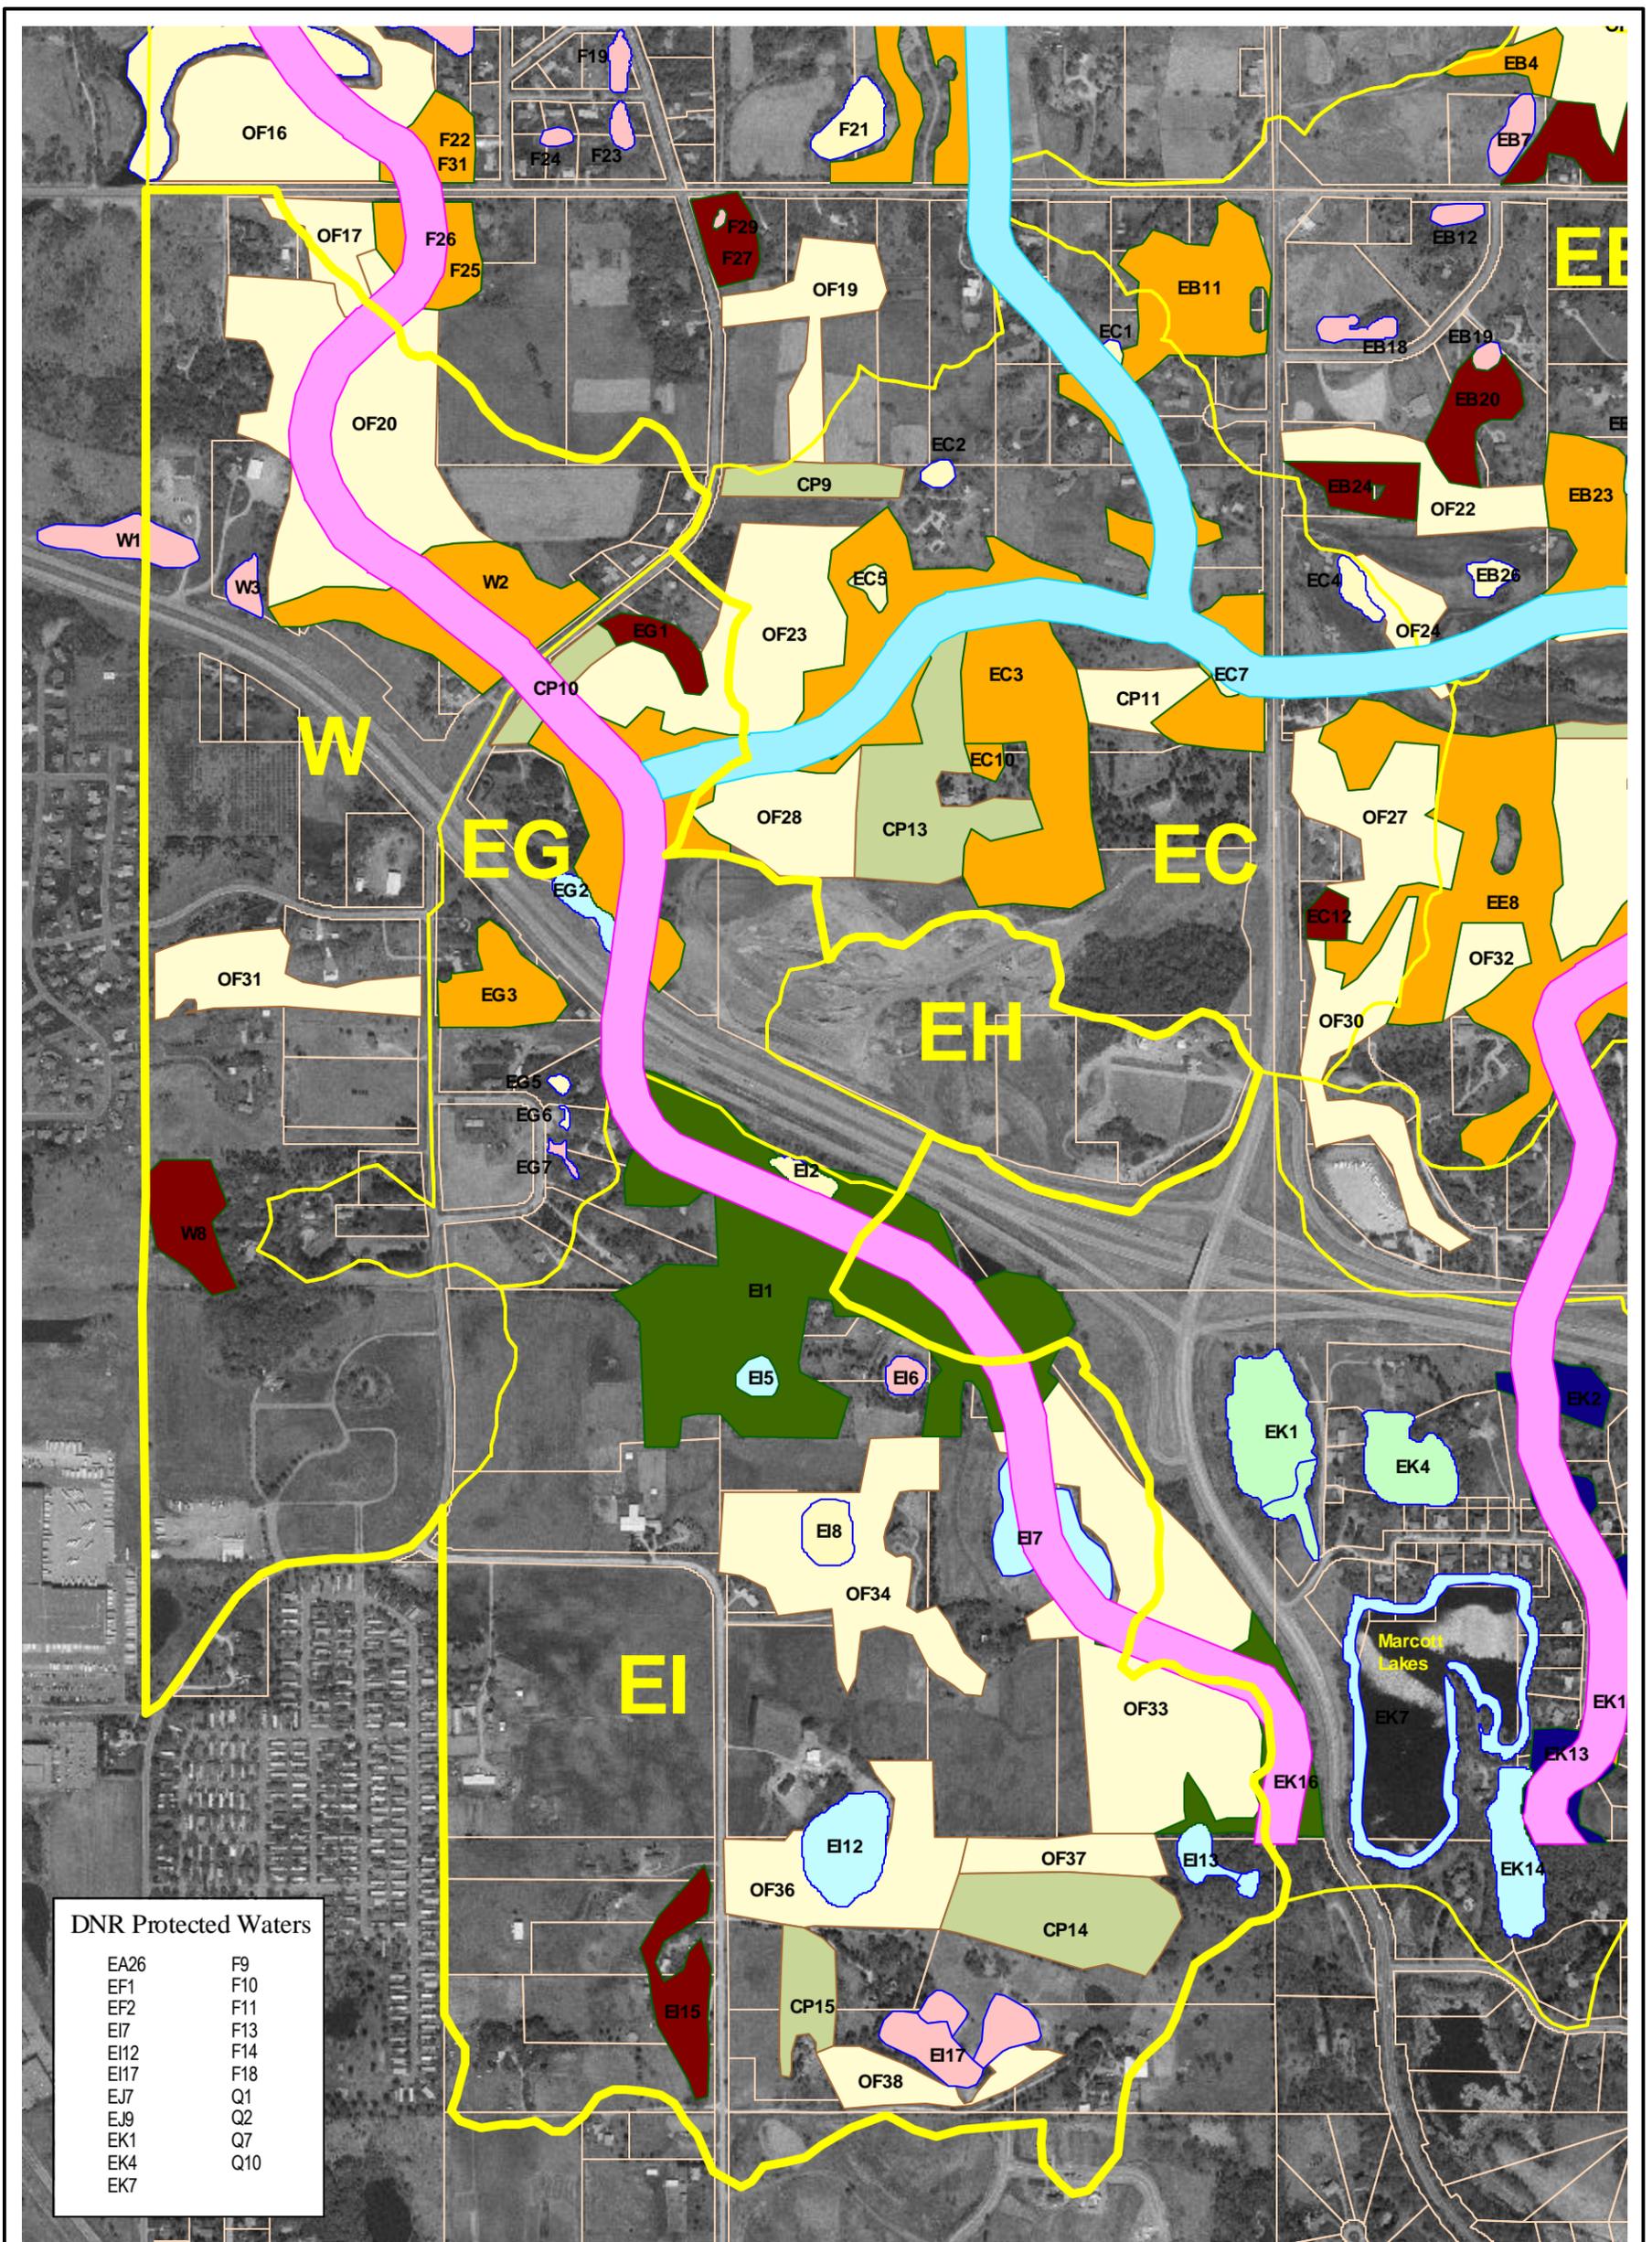
Wetland and Upland Management Classification: SW Quadrant

REFER TO SOUTHWEST QUADRANT FIGURE

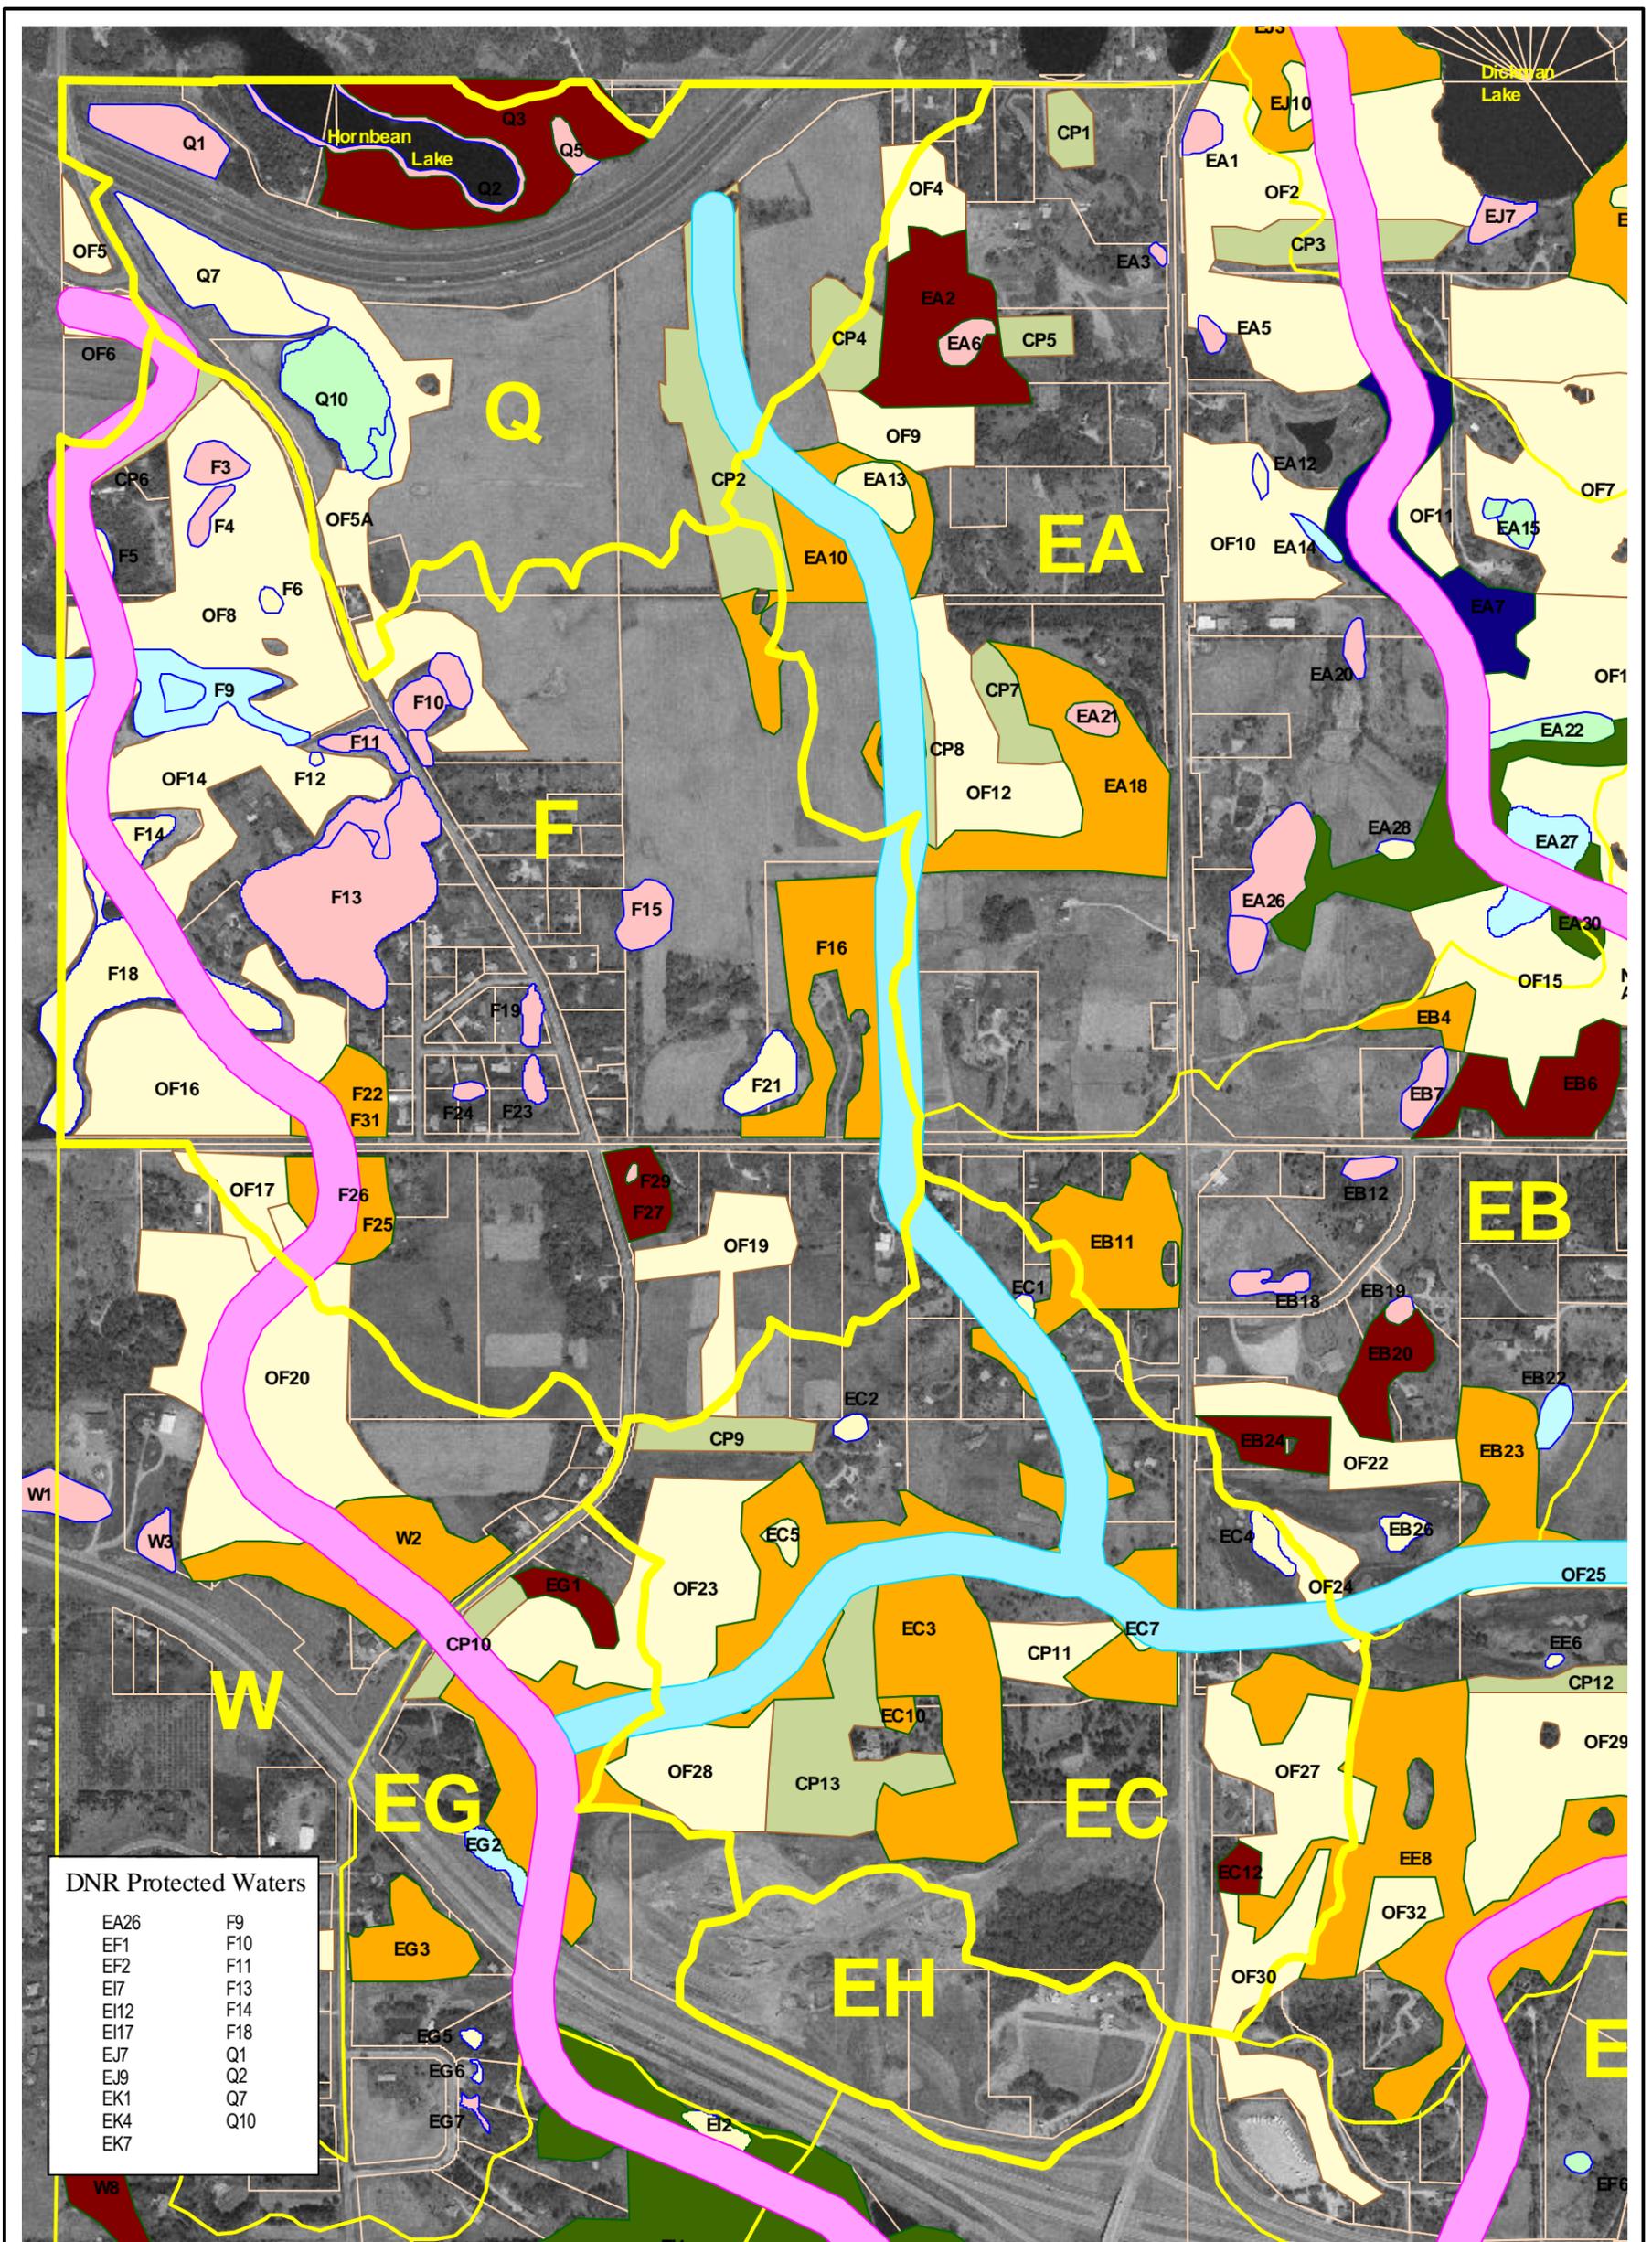
Wetland and Upland Management Classification: NW Quadrant

REFER TO NORTHWEST QUADRANT FIGURE

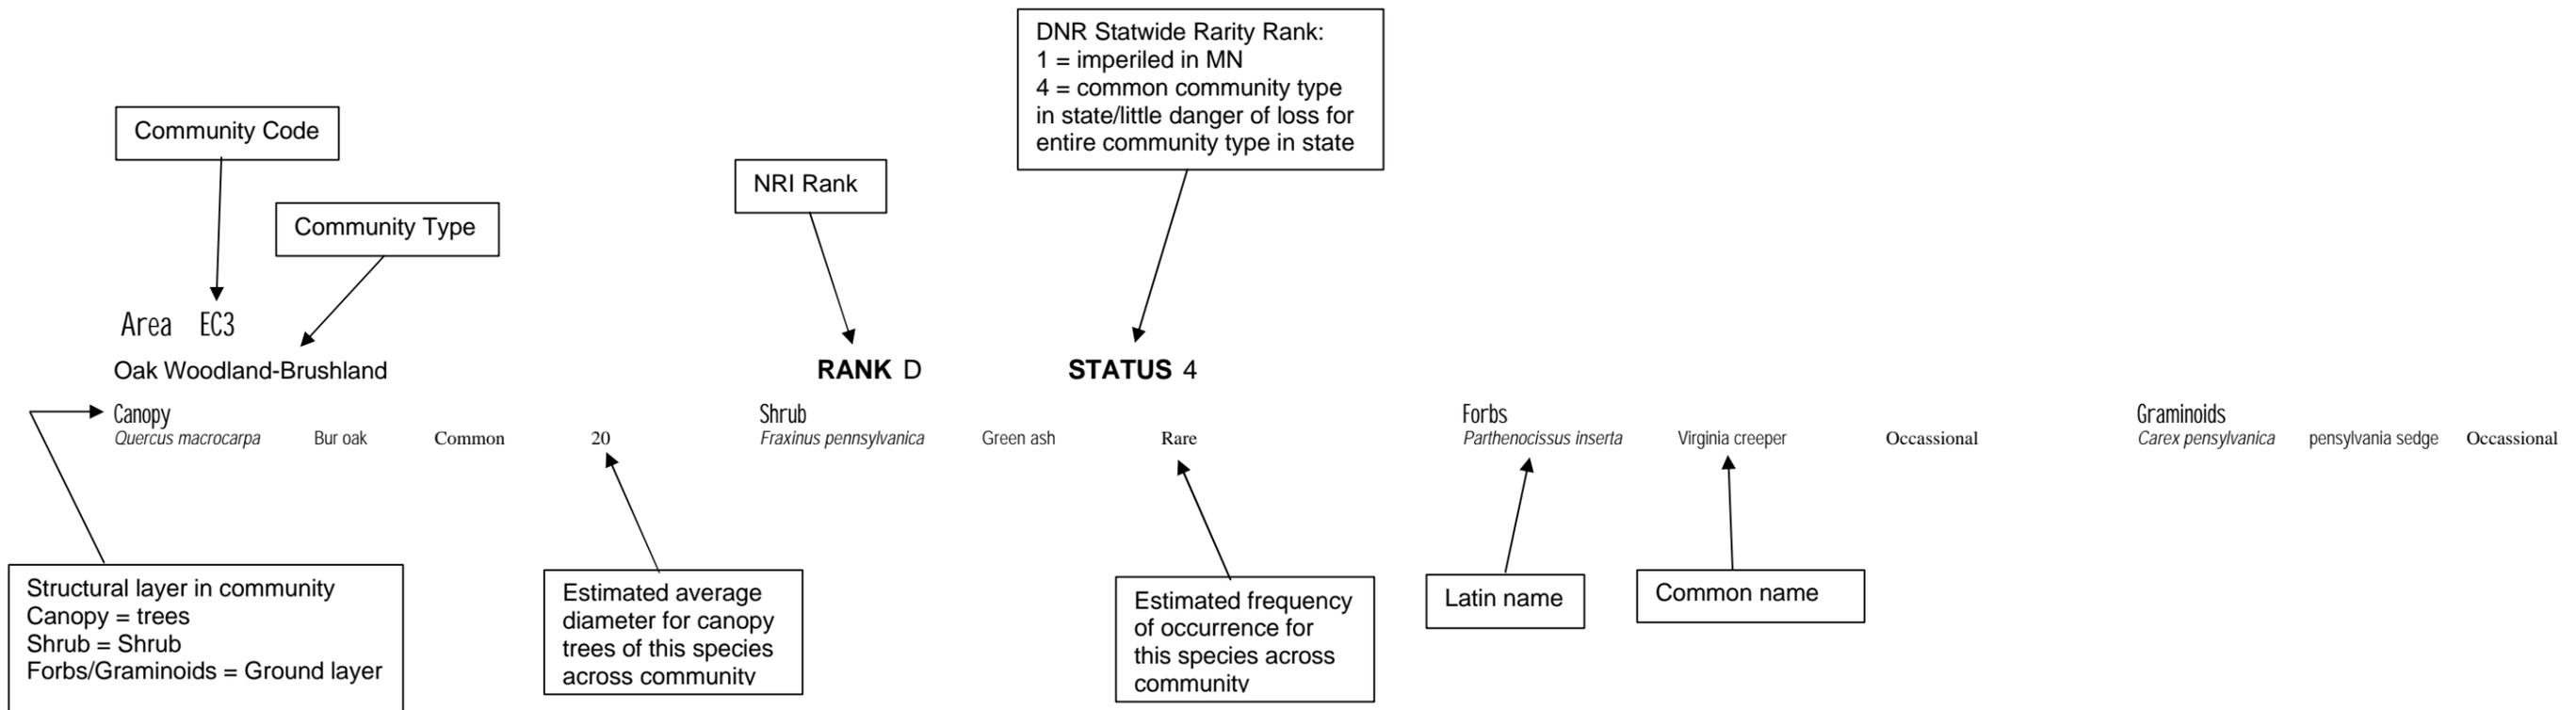
This section contains species lists and other data for individual upland natural areas visited as a part of this study. Below is a sample header for an individual community, along with an explanation of the various aspects.

It is important to note that the frequency of occurrence noted for individual plant species (common, occasional, rare) denotes how often a particular plant species was encountered in that community. **The terminology used in this report to characterize the frequency of occurrence for plants is not, and should not be associated with State- or Federal-listed plant species (Endangered, Threatened, Special Concern).**
